The Effectiveness of Earthquake and Tsunami Evacuation Symbols and Signs for the Deaf Community in Public Spaces of Banda Aceh

Evacuation Symbols,
Deaf Community,
Visual Communication,
Disaster Mitigation,
Banda Aceh

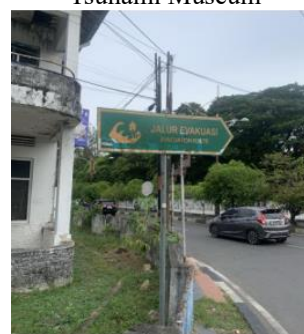
Figure 4. Direction to Evacuation Symbol

4. Direction to Evacuation Symbol	Right arrow, bilingual text "Evacuation Route", tsunami icon	The elongated horizontal composition is quite clear and communicative. However, bilingual text placement lowers visual focus due to space competition between text and icons. Text kerning is relatively good but the font size is small for highway readability.	The dark green color is close to #2E7D32 with white text. Some areas show fading and scratching on the surface.	By design it is closest to universal standards, but the scale and visual maintenance need to be improved to be effective for users with high visual dependency such as the deaf.
